Manhole Inspection Summary

Manhole # S35AA_036MH

Insp Date: **11/15/07 8:59 AM**

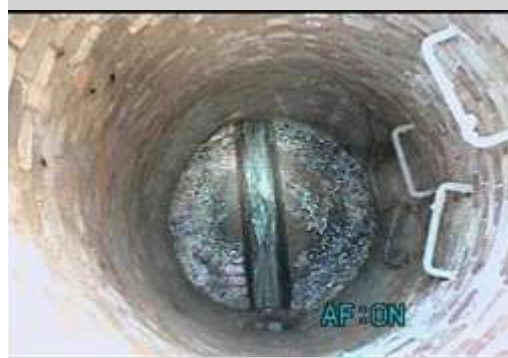
Top View

Comments **Had a drop at 6, a fractured corbel & infiltration in barrel**

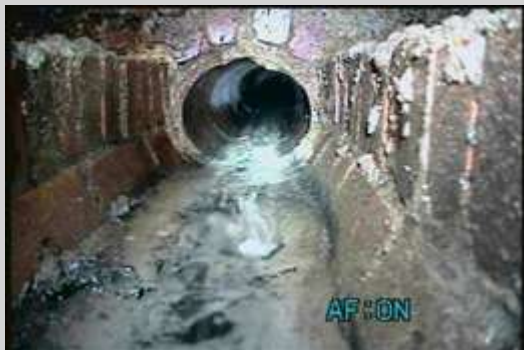
12 O'Clock Outflow

8 in. Circular Gravity Sewer
Pipe Out @ 12 O'Clock

Invert Depth: 12.00 (ft.) Flow Characteristics: Slow

Infiltration: None Pipe Seal Cond: Unknown

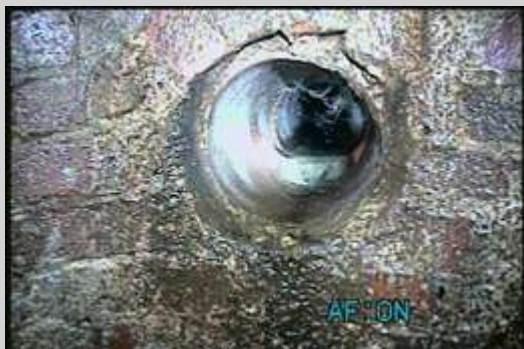
6 O'Clock Inflow

8 in. Circular Gravity Sewer
Pipe In @ 6 O'Clock

Infiltration: None Pipe Seal Cond: Unknown

Drop Condition: Open
